NEW SITE IDENTIFICATION

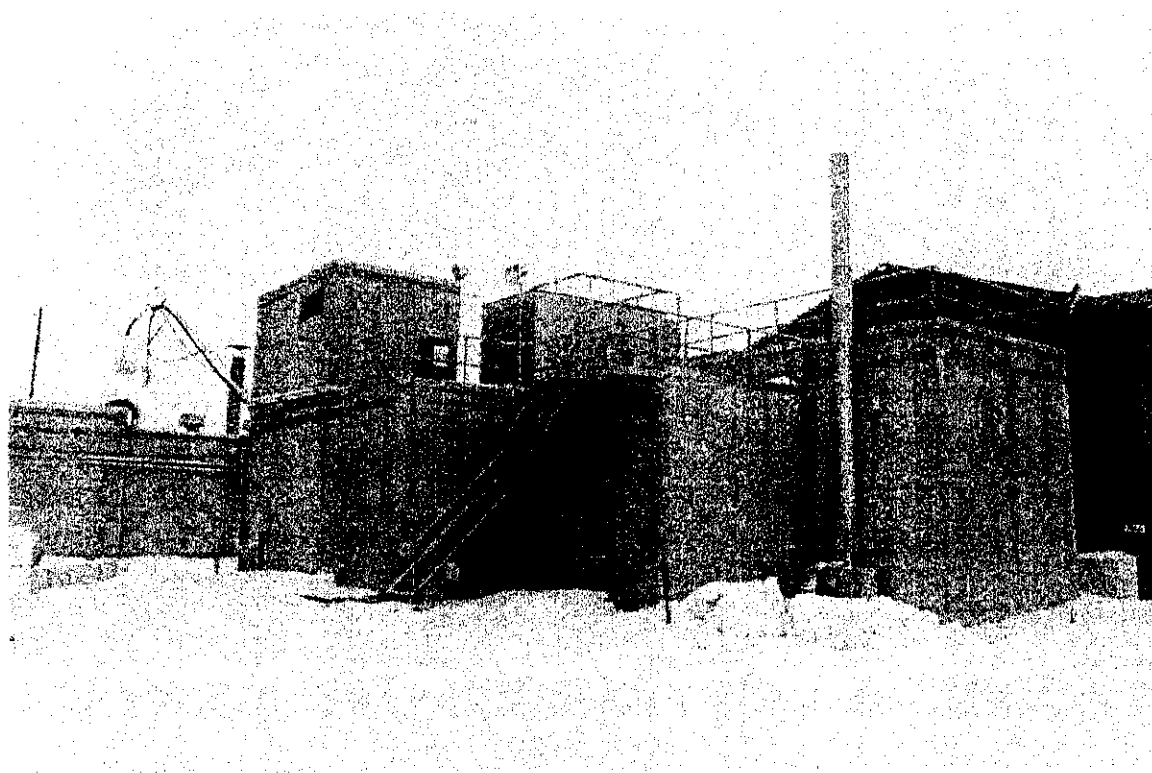
Photo 1. TAN 616 Liquid Waste Treatment Facility

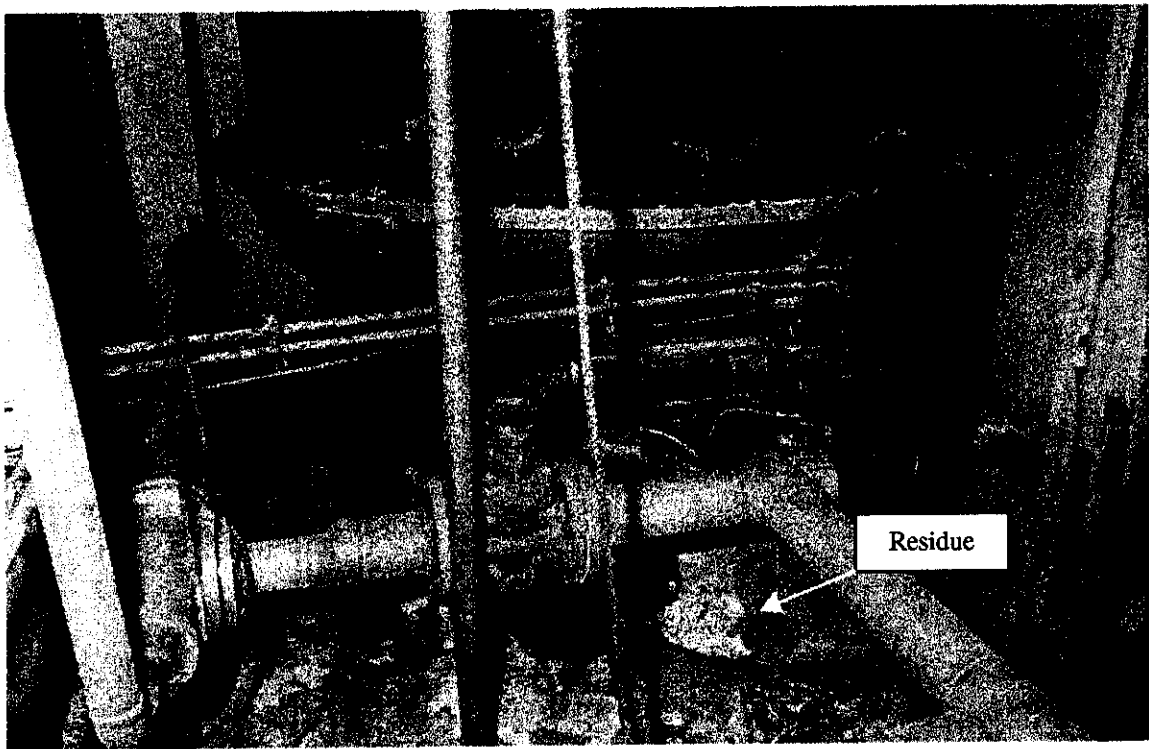
Photo 3. Residue Build Up

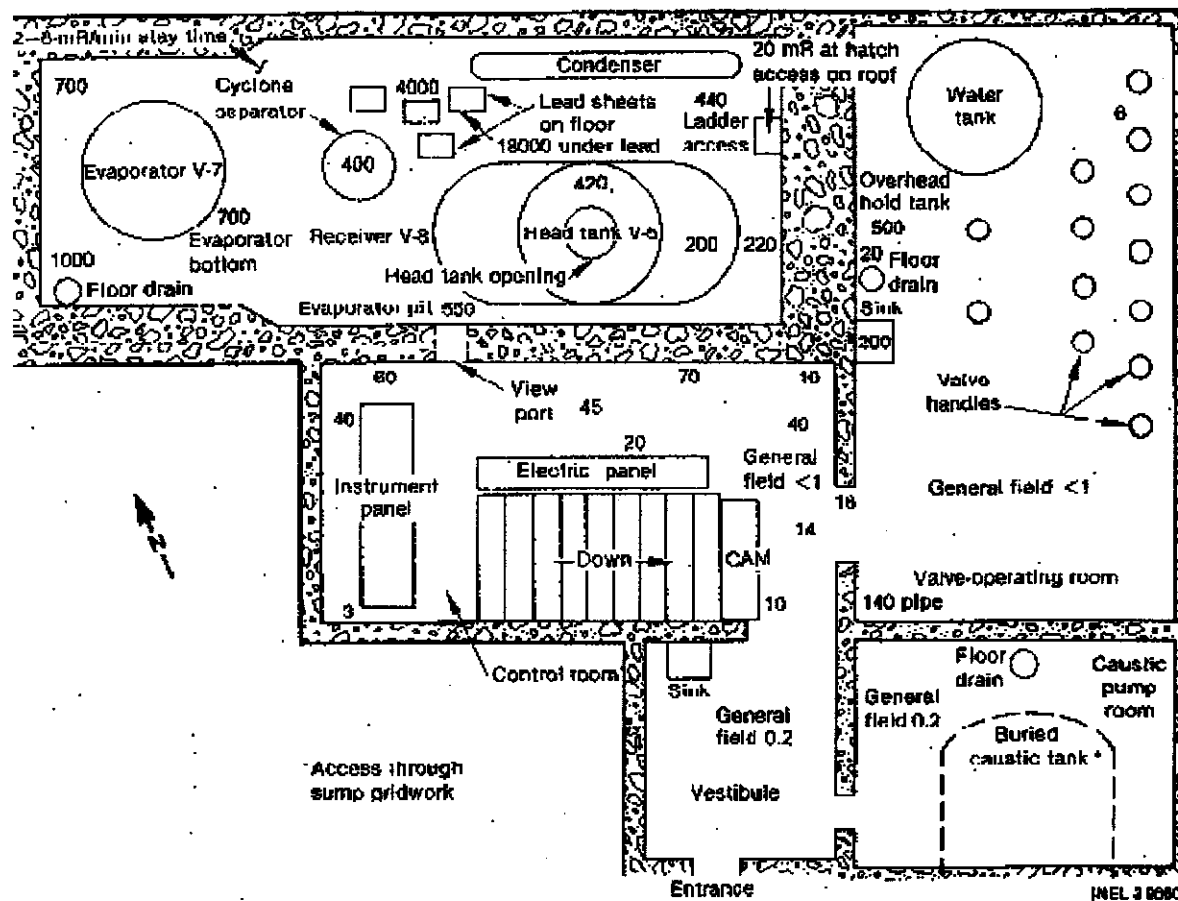
Figure 2B. Radiation survey readings on TAN-616 main floor (in mR/hr).

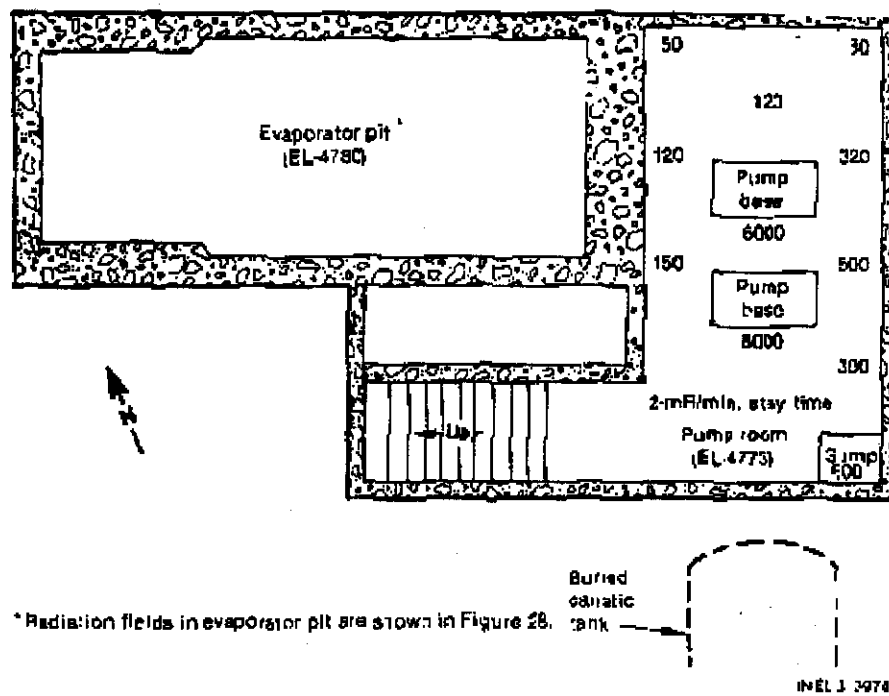
Figure 29. Radiation survey readings in TAN-616 basement (in mR/hr).
